MARYLAND GEOLOGICAL SURVEY
Merryman Hall
The Johns Hopkins University
Baltimore, Maryland 21218
(301) 235-0771

M&D milestone no. 19 (20)

MHT-HSI no. CE-VIII-1026

FIELD SHEET: MASON & DIXON LINE, MARYLAND-PENNSYLVANIA BOUNDARY MARKER SURVEY

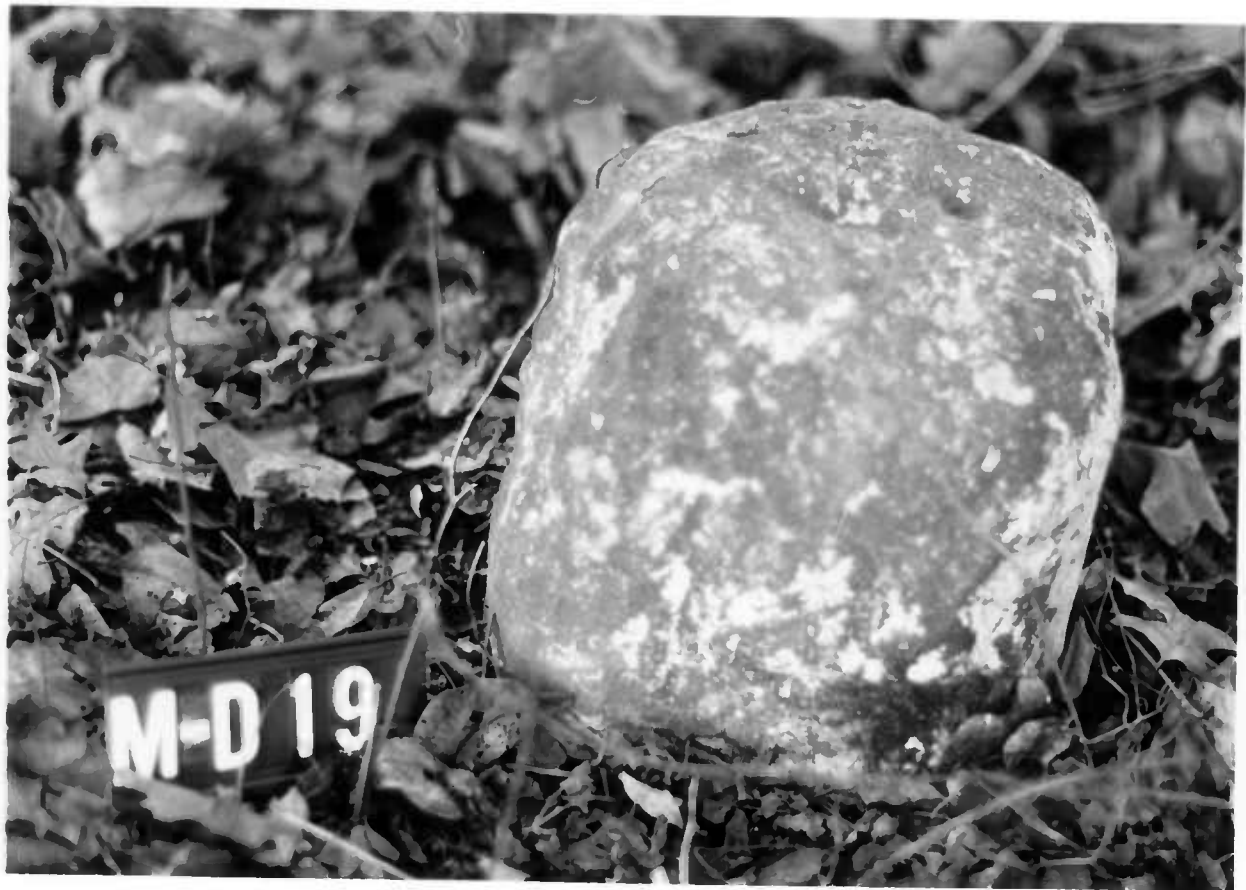
E face: 11" wide x 13" high; fluting & margins gone, face scarred, badly weatherworn & chipped; all edges & corners rounded

S face (MD): 11" wide x 13" high; only left half of letter M remains, circle panel, fluting & margins gone; all edges chipped & weatherworn

South and East sides
